ERNEST ORLANDO LAWRENCE BERKELEY NATIONAL LABORATORY

Duct Tape Durability Testing

M.H. Sherman and I.S. Walker

April 2004

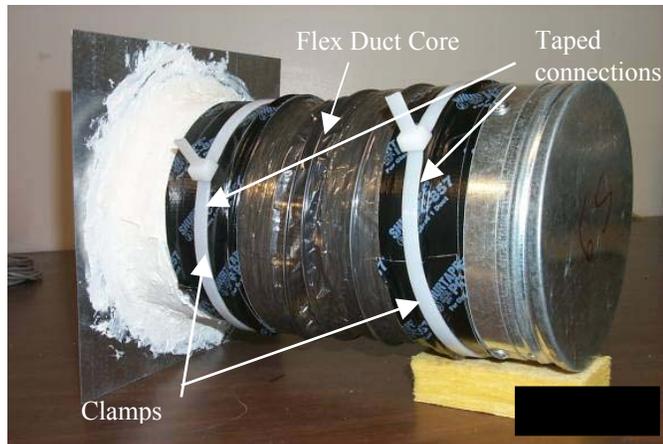
Figure 1. Example of a core-to-collar test sample showing the two taped connections and the mechanical clamps.

The core-to-collar duct connection consisted of a six inch diameter (150 mm) round collar to flex duct core (an example is shown in Figure 1). Four different UL 181-listed duct tape products were used generically called in this report as Tape 1, Tape 2, Tape 3, and Tape 4. Tapes 1 and 2 are conventional duct tapes. Tape 3 is an OPP, acrylic adhesive tape. Tape 4 is a foil-backed, butyl adhesive tape. A nylon strap was used to mechanically hold the connection together for 10 of the 18 samples. The tapes were applied using different combinations of the number of wraps and multiple pieces of tape. Table 1 summarizes the different combinations of tape type, clamping, and wrapping that were tested.

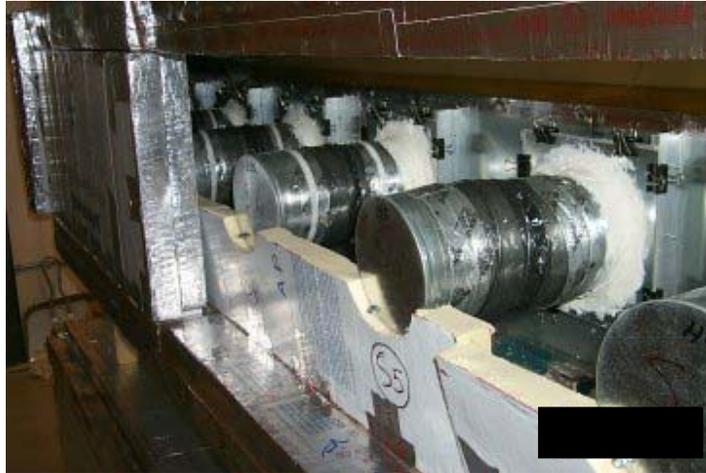
Figure 2. One chamber of the high temperature aging test apparatus.

Figure 2 shows samples mounted on the aging test apparatus. Heated air is continuously circulated through the test apparatus to both heat and pressurize the leakage sites. The apparatus is divided into an upper and lower chamber that each contains nine samples. The inside of the test samples are exposed to high pressure (0.34 inch water (84 Pa)) heated air and the outside (shown in Figure 3) is in an insulated chamber that also becomes heated

during the experiments by conduction through the test samples. This means that there is little temperature gradient across the samples. The hot air temperature(200 °F (93 °C)) is controlled using electric resistance heaters mounted directly in the air stream. The surface temperatures of each sample, the air temperature and the pressure across the leaks are continuously monitored using a computer based data acquisition system.

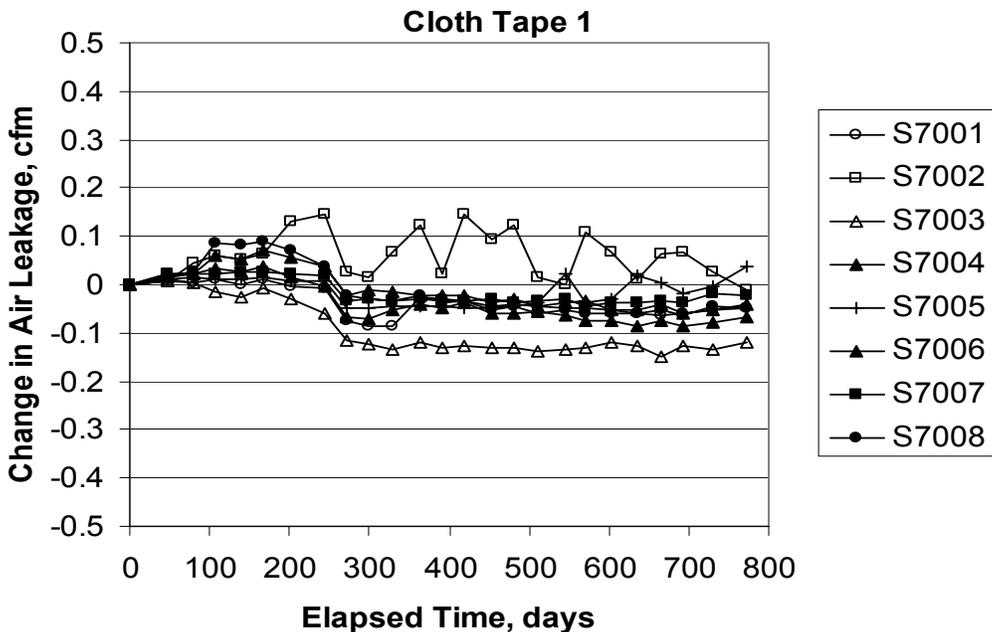
Figure 3. Change in leakage flow of the flexible core to sheet metal collar joint specimens with cloth tape 1.

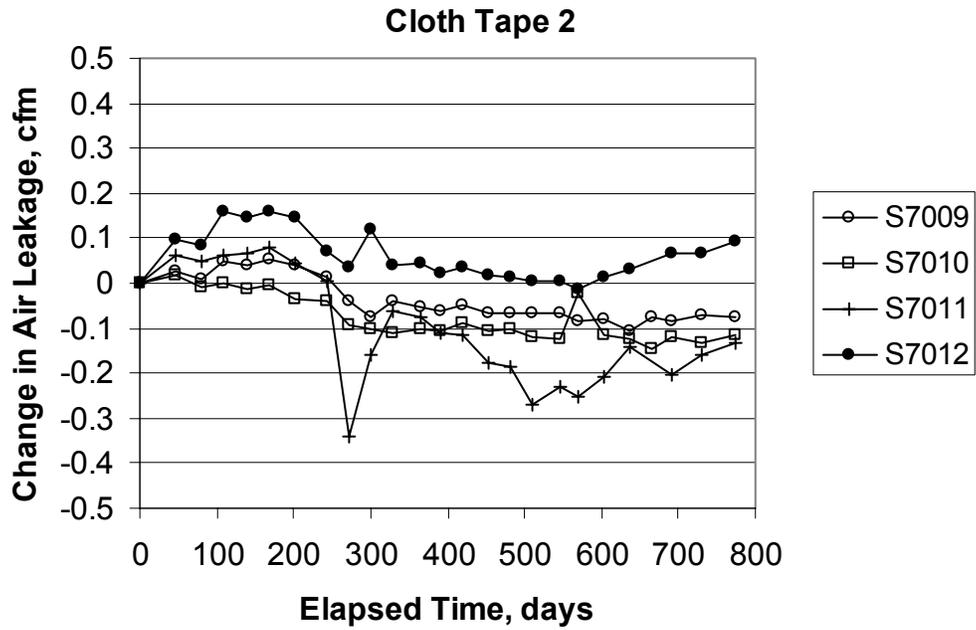
Figure 4. Change in leakage flow of the flexible core to sheet metal collar joint specimens with cloth tape 2.

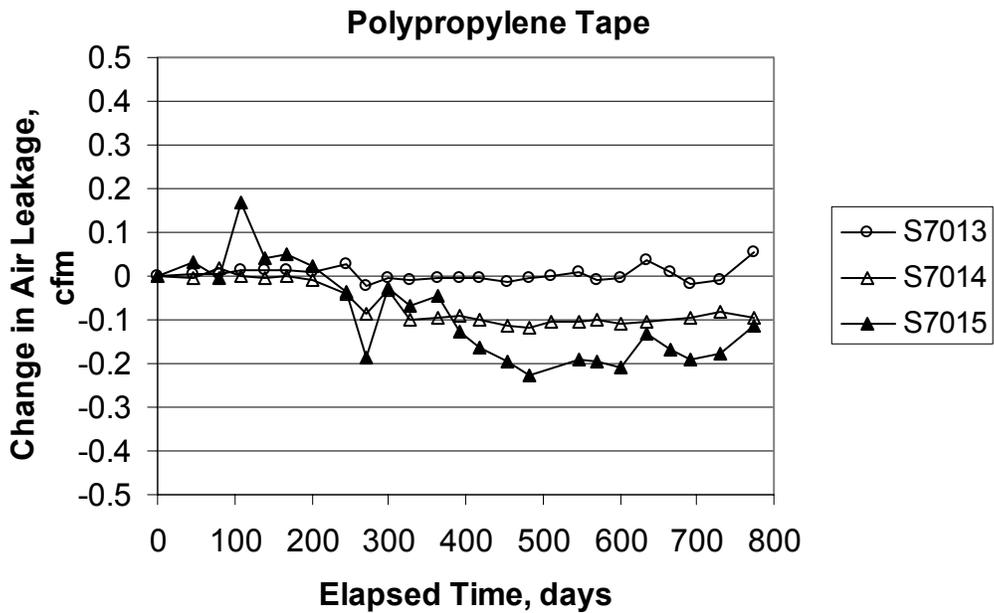
Figure 5. Change in leakage flow of the flexible core to sheet metal collar joint specimens with polypropylene tape 3.

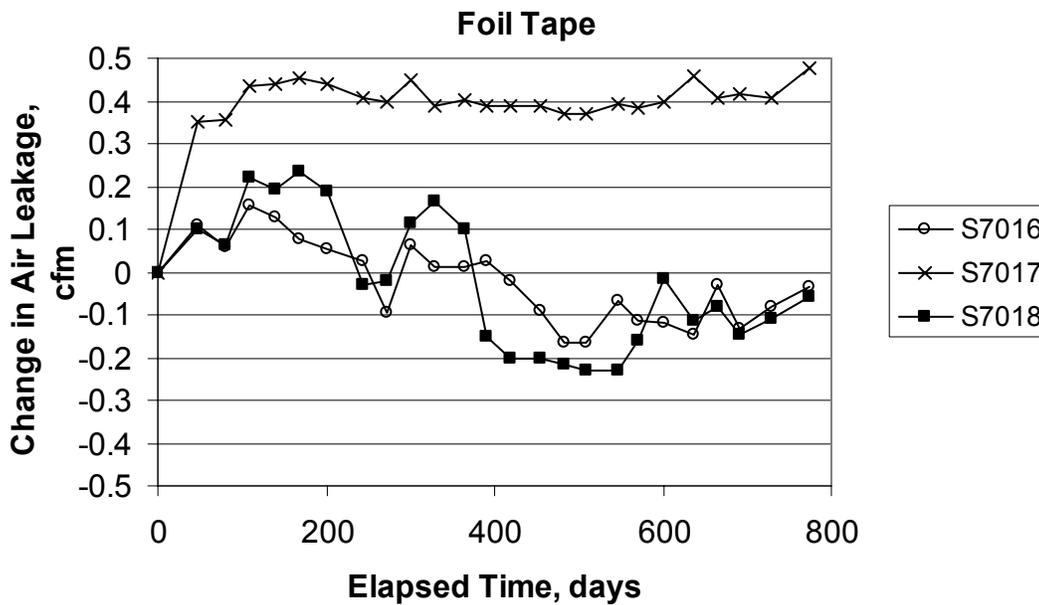
Figure 6. Change in leakage flow of the flexible core to sheet metal collar joint specimens with foil tape 4.

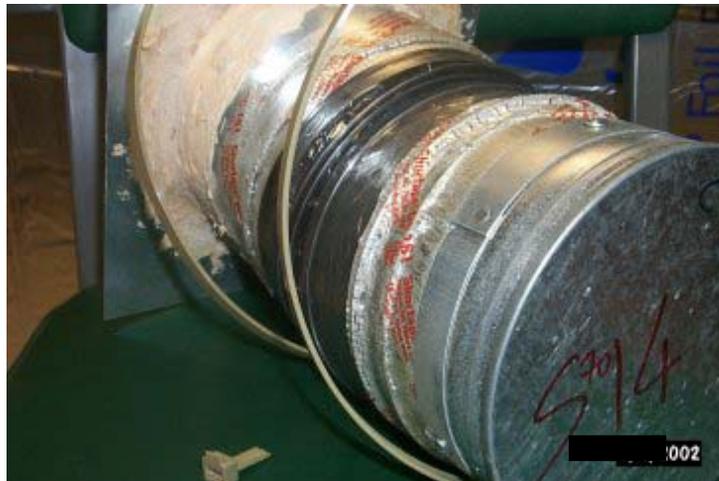
Figure 7. Failed plastic strapping on one of the flexible core to sheet metal collar specimens after four months of aging.

One sample (S7014) had strap failure after four months of aging (Figure 7). Other straps lasted longer, however, all but two failed by the end of testing. The two remaining straps show the same discoloration as failed straps – but have not completely fallen off. The results show no significant pattern for flange or end caps failing first, the two straps on each sample generally failed within a couple of months of each other. Strap failure potentially is a major problem because mechanical attachment thereafter only is maintained by the duct sealant. If ducts are not well-supported, significant mechanical stress can occur to cause the sealant to fail after the clamp fails.

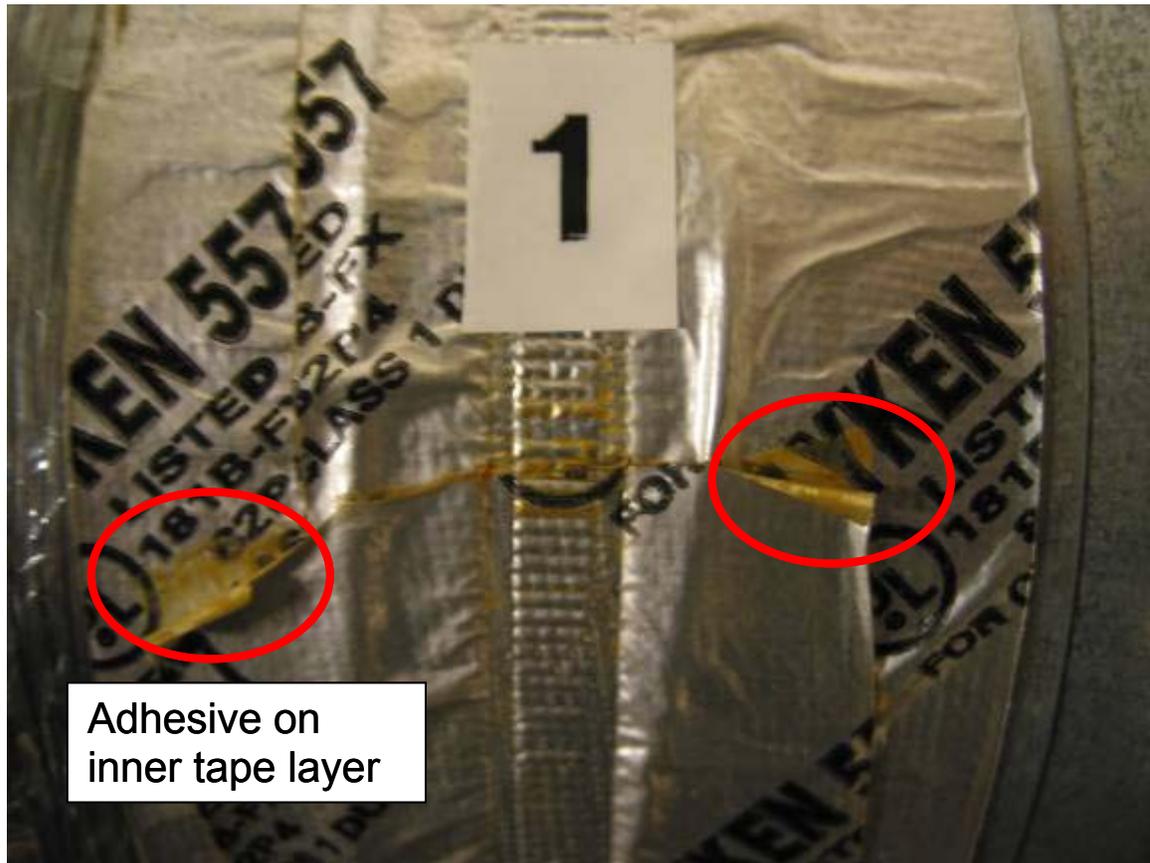
Figure A1. Sample 1. This figure shows the curling of the tape end where it is no longer stuck to the inner layer of tape. The yellow (circled) areas show where the adhesive has remained on the inner tape layer. The tape edges have curled away from the duct and the tape surface is wrinkled. The indentations in the center of the tape shows where the strap used to be before it fell off.

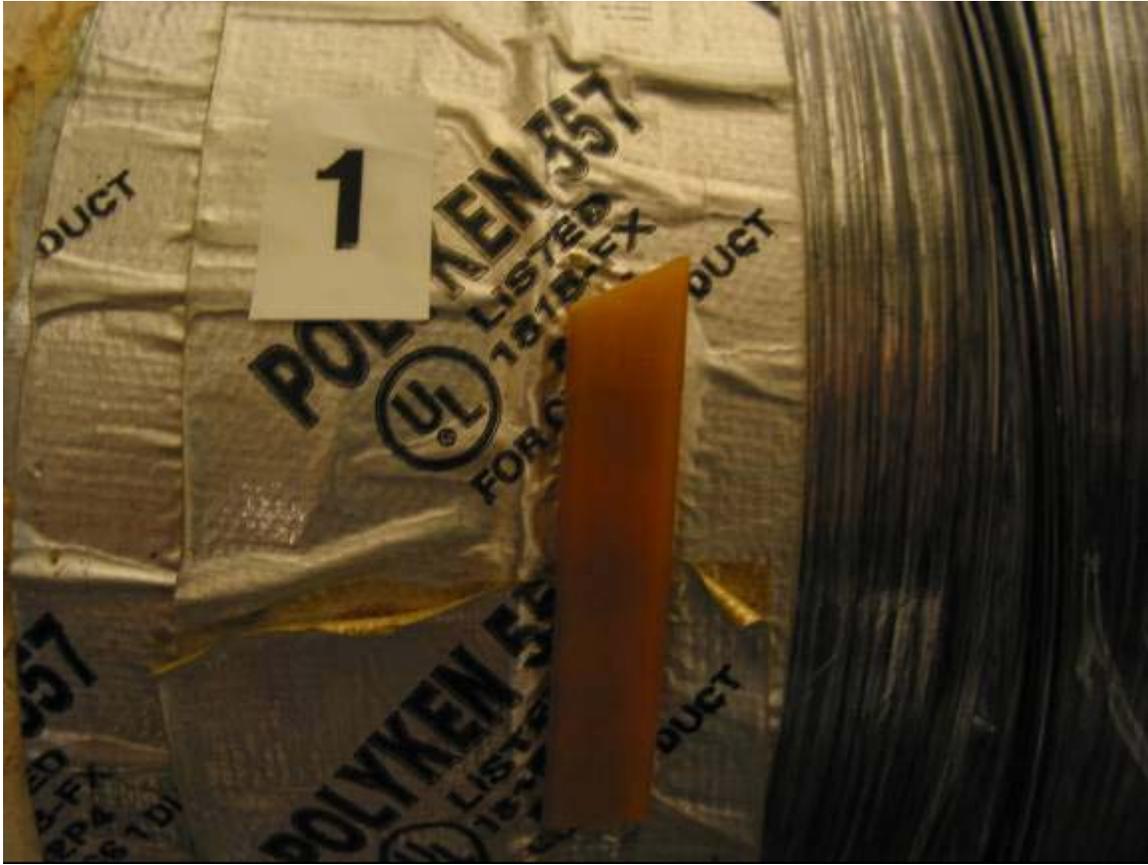
Figure A2. Sample 1. The second seal still has part of the nylon clamp in place. This shows the same characteristics as in Figure A1.

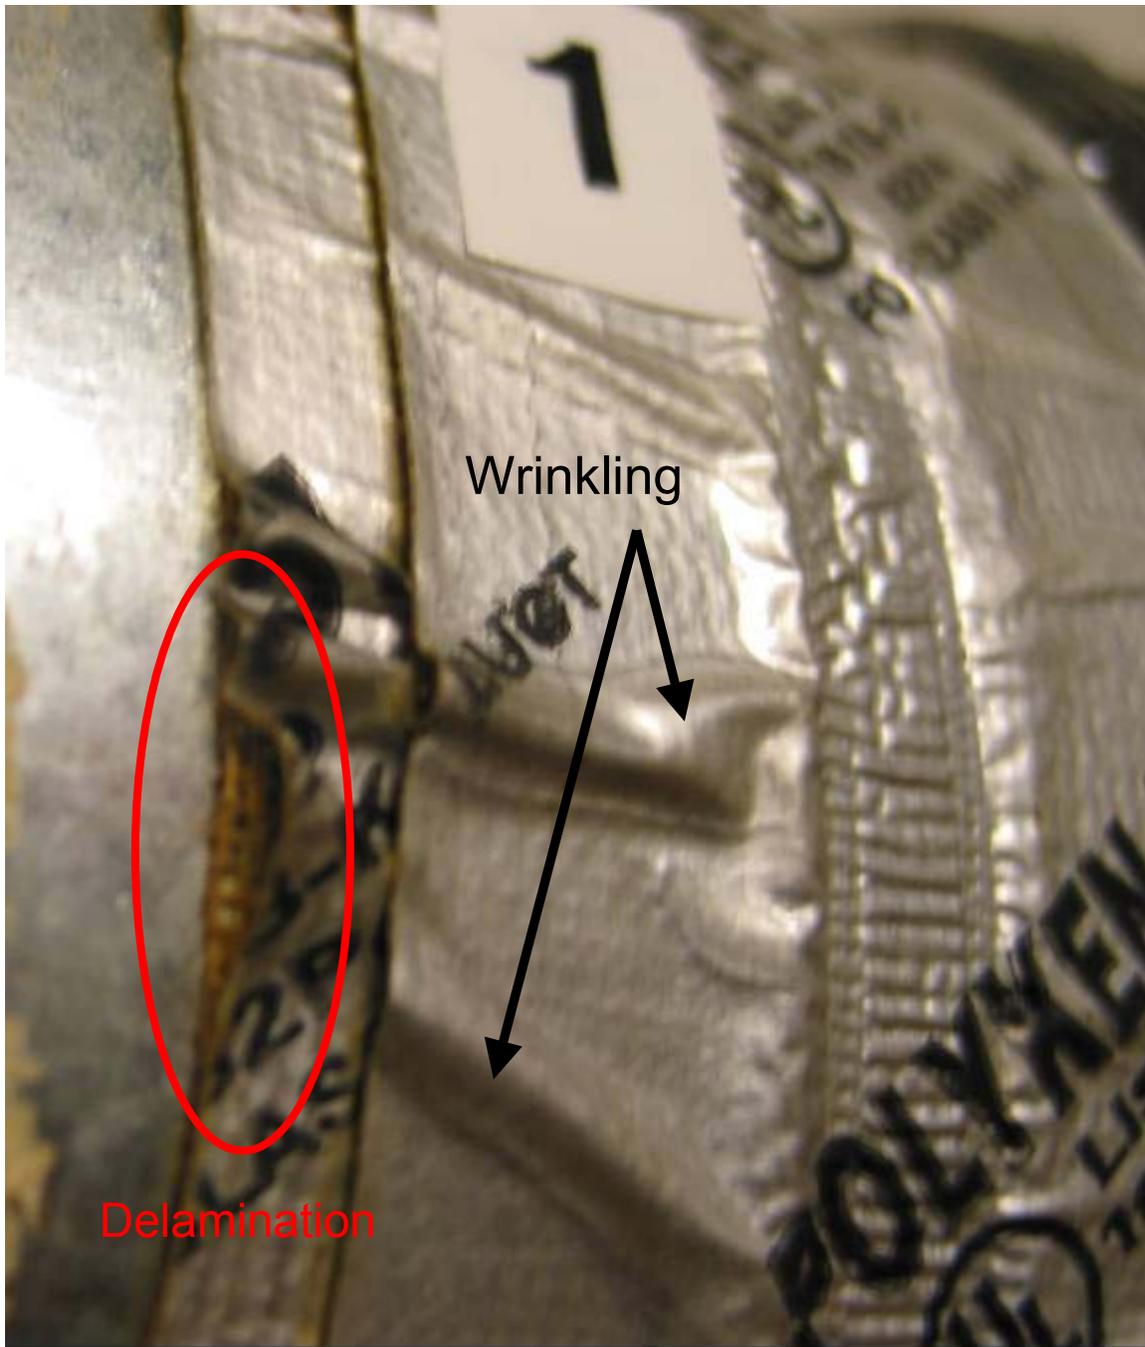
Figure A3. Sample 1. The tape shows wrinkling and delamination of the reinforcing mesh from the tape backing.

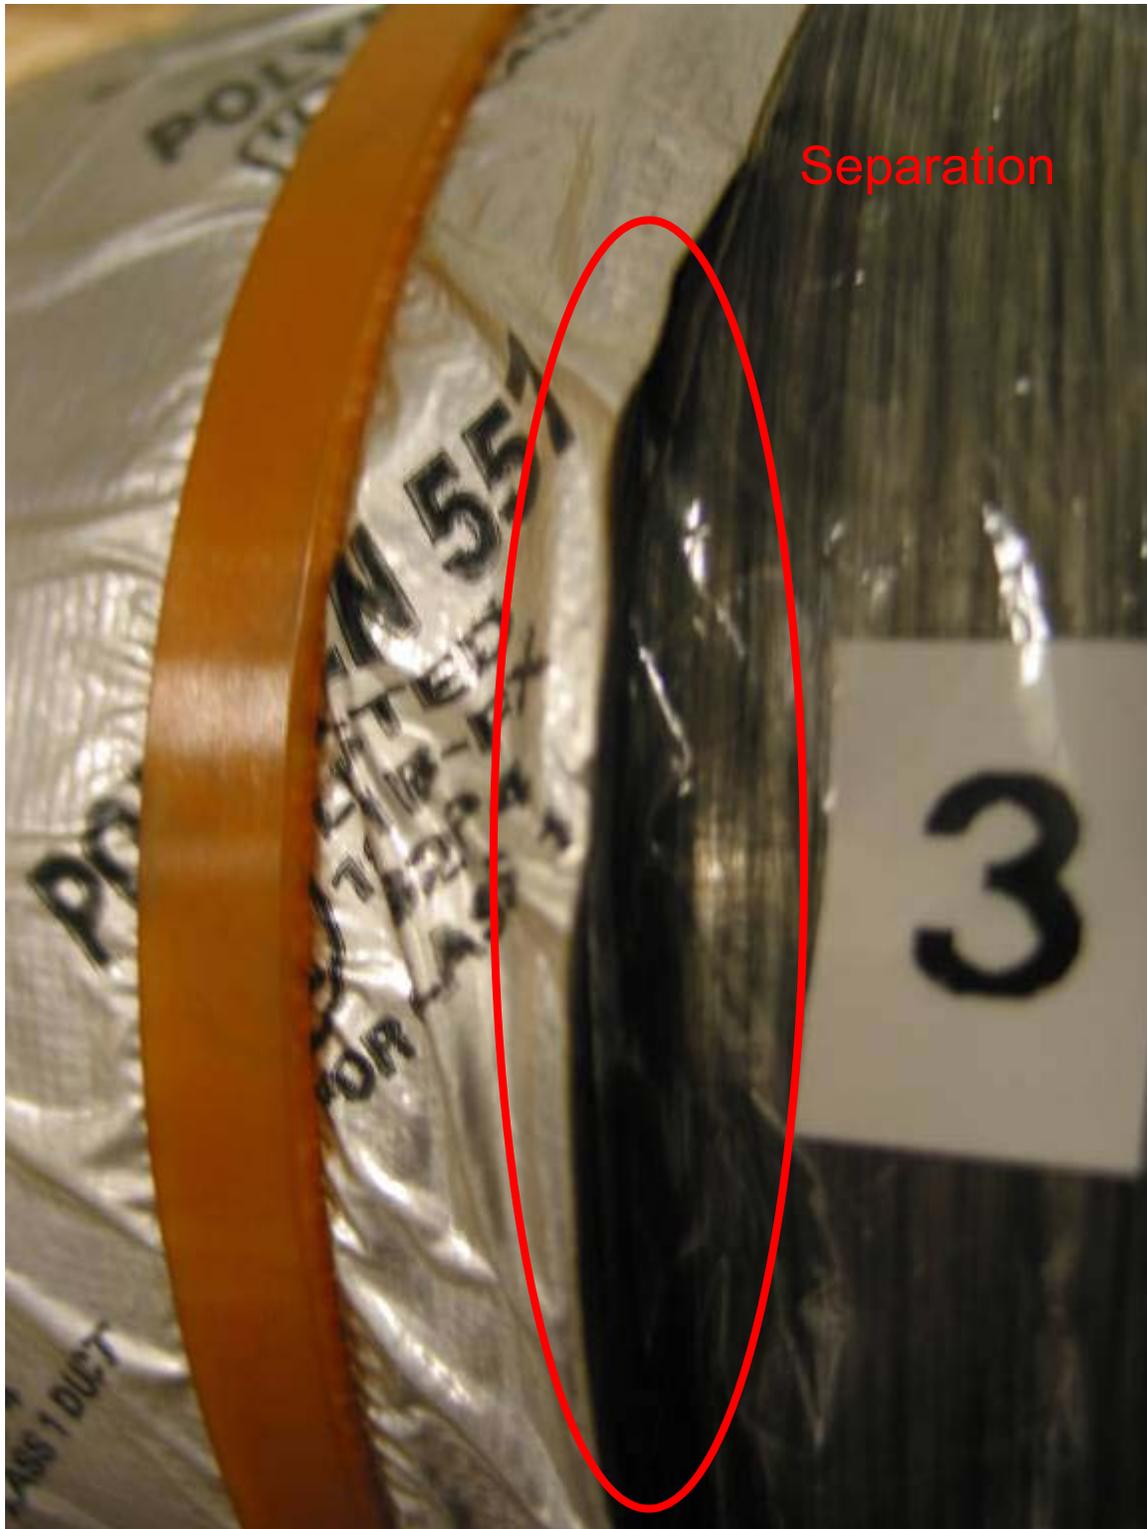
Figure A4. Sample 3. Tape has separated from the flex duct core at the tape edges

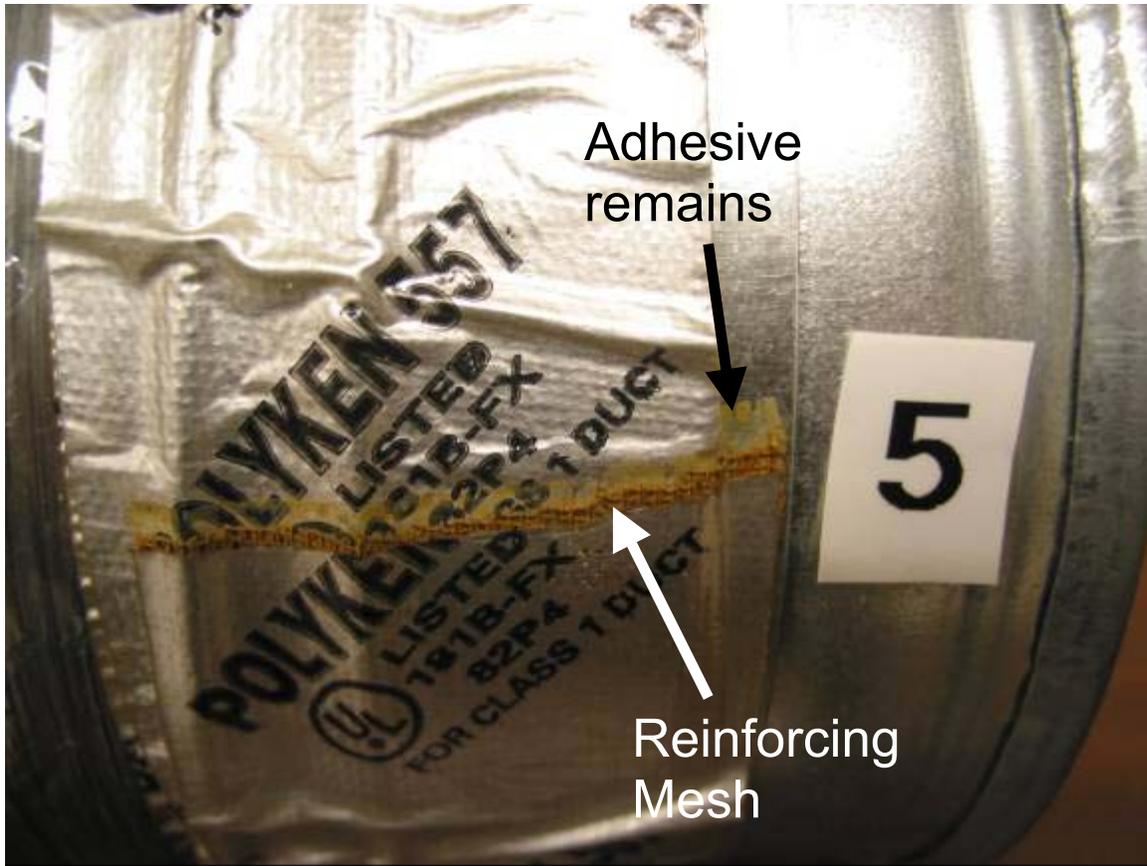
Figure A5. Sample 5. The end of the tape shows shrinkage and delamination. Compare this to Figure A1, where the presence of the clamp in A1 reduces the shrinkage and delamination at the center of the tape. This figure clearly shows the adhesive left where the tape was originally attached and the reinforcing mesh separated from the backing.

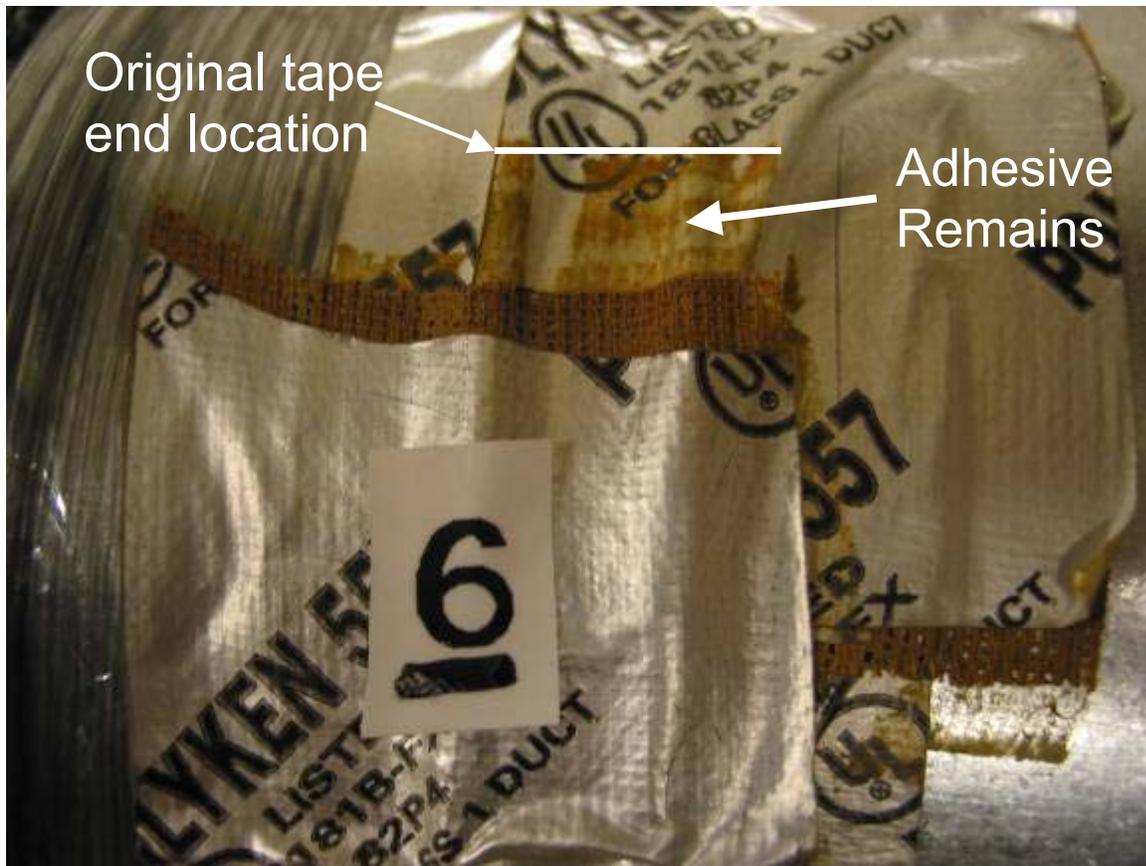
Figure A6. Sample 6. This figure is similar to Figure A5, but shows even more shrinkage.

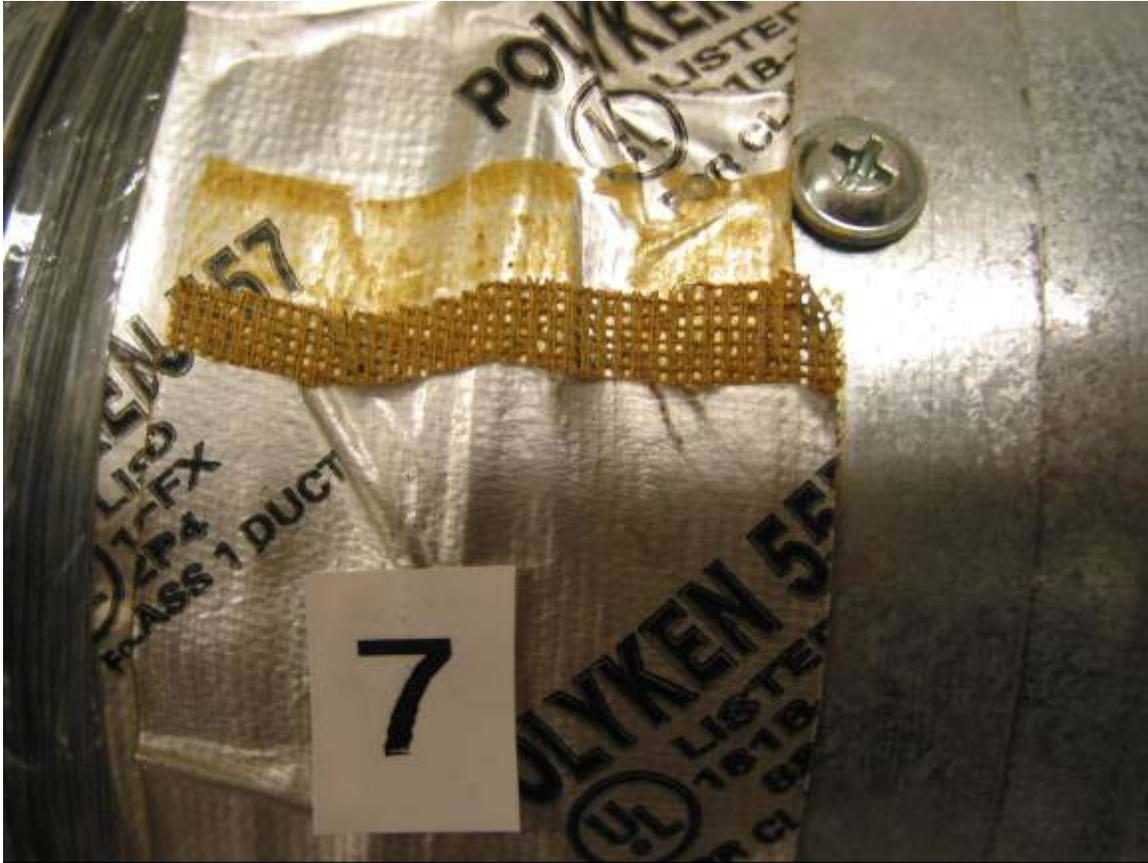
Figure A7. Sample 7. Like sample 6, sample 7 shows considerable shrinkage and delamination.

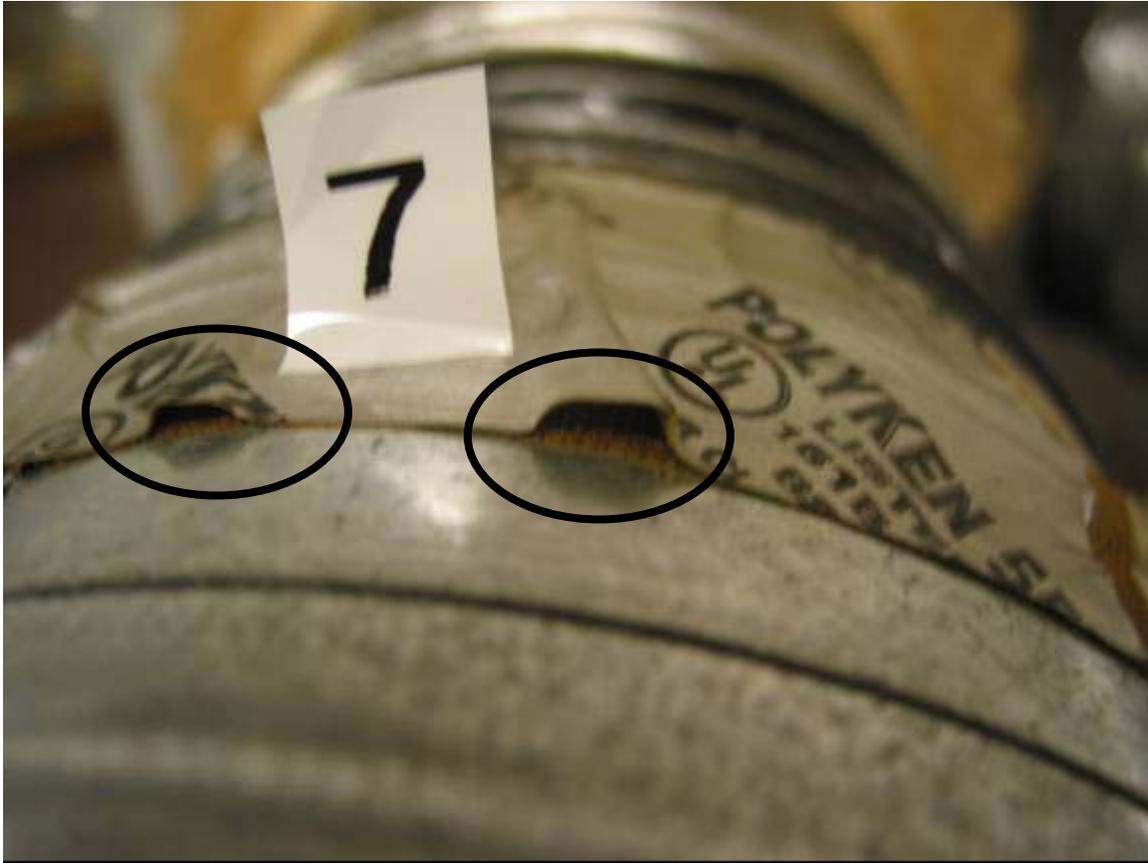
Figure A8. Sample 7. The edges of the tape have lifted off the duct surface in large wrinkles.

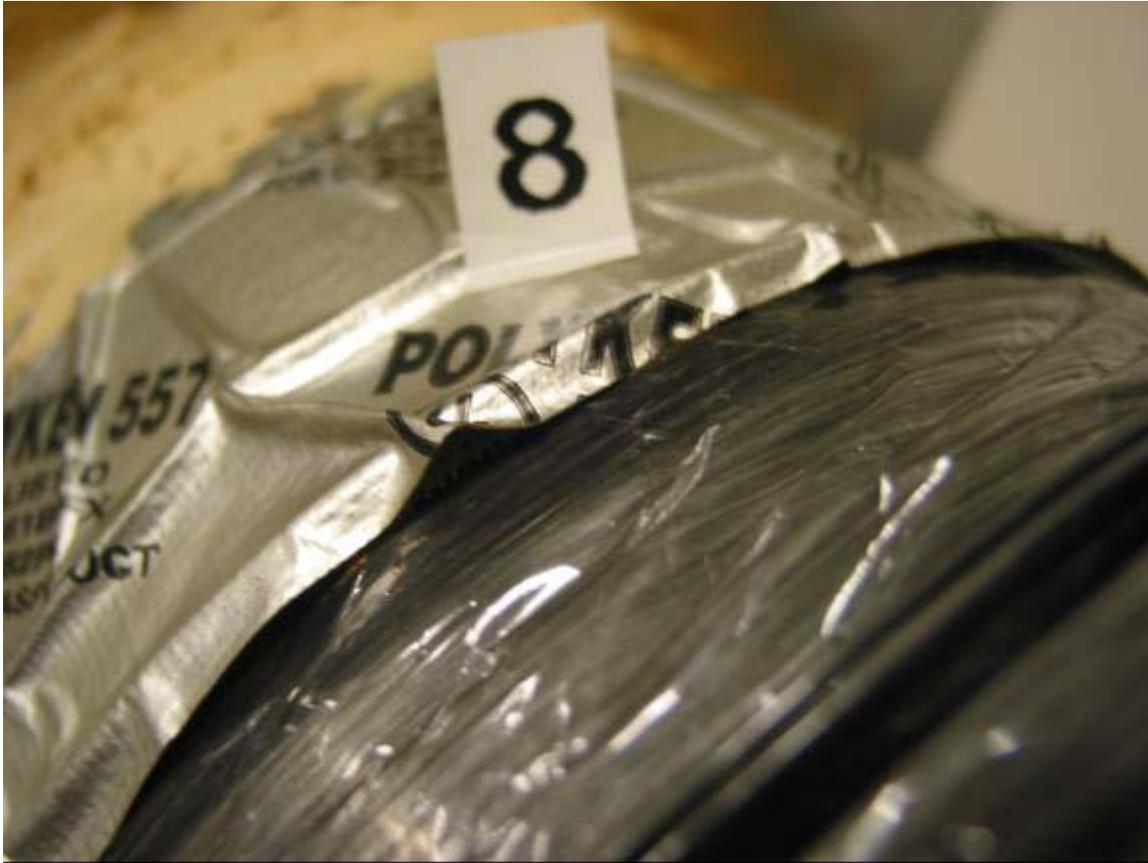
Figure A9. Sample 8. The edges of the tape are no longer stuck to the flex duct core.

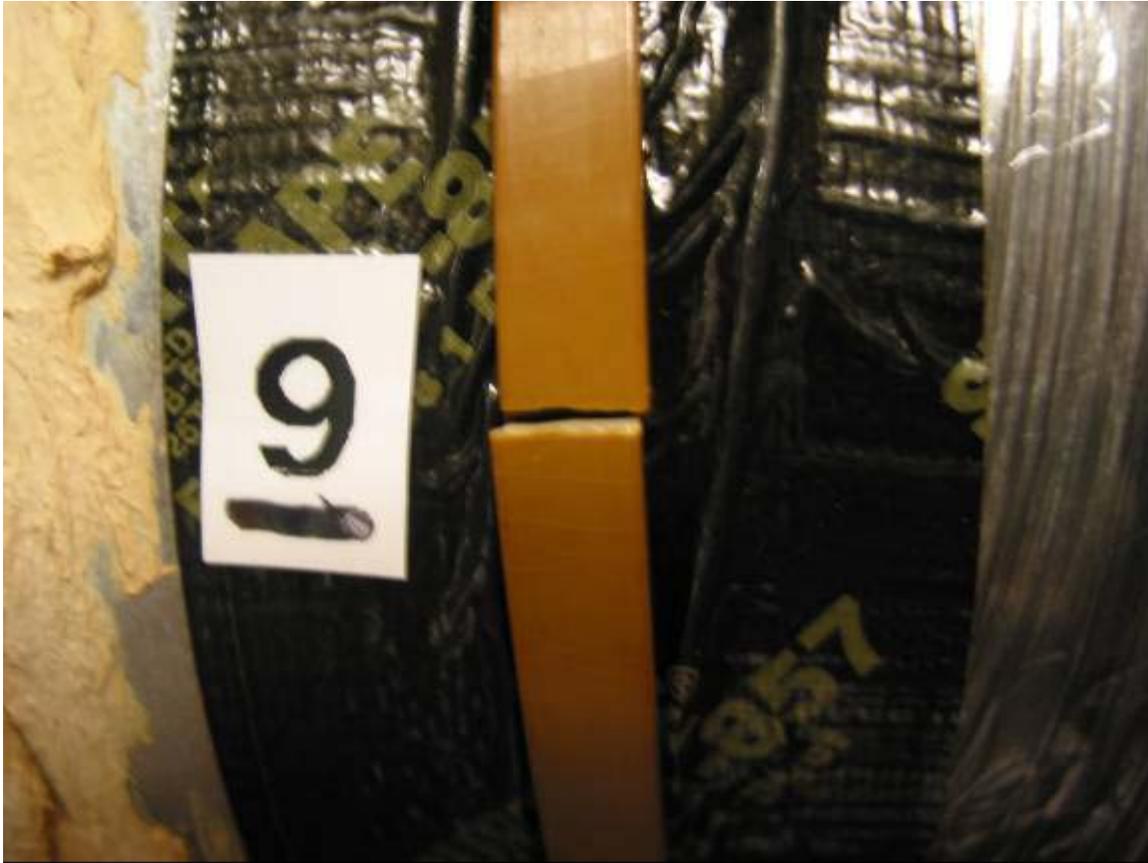
Figure A10. Sample 9. The clamp shows its brittle failure. Note that these clamp sections are now held in place because they are stuck to the duct tape.

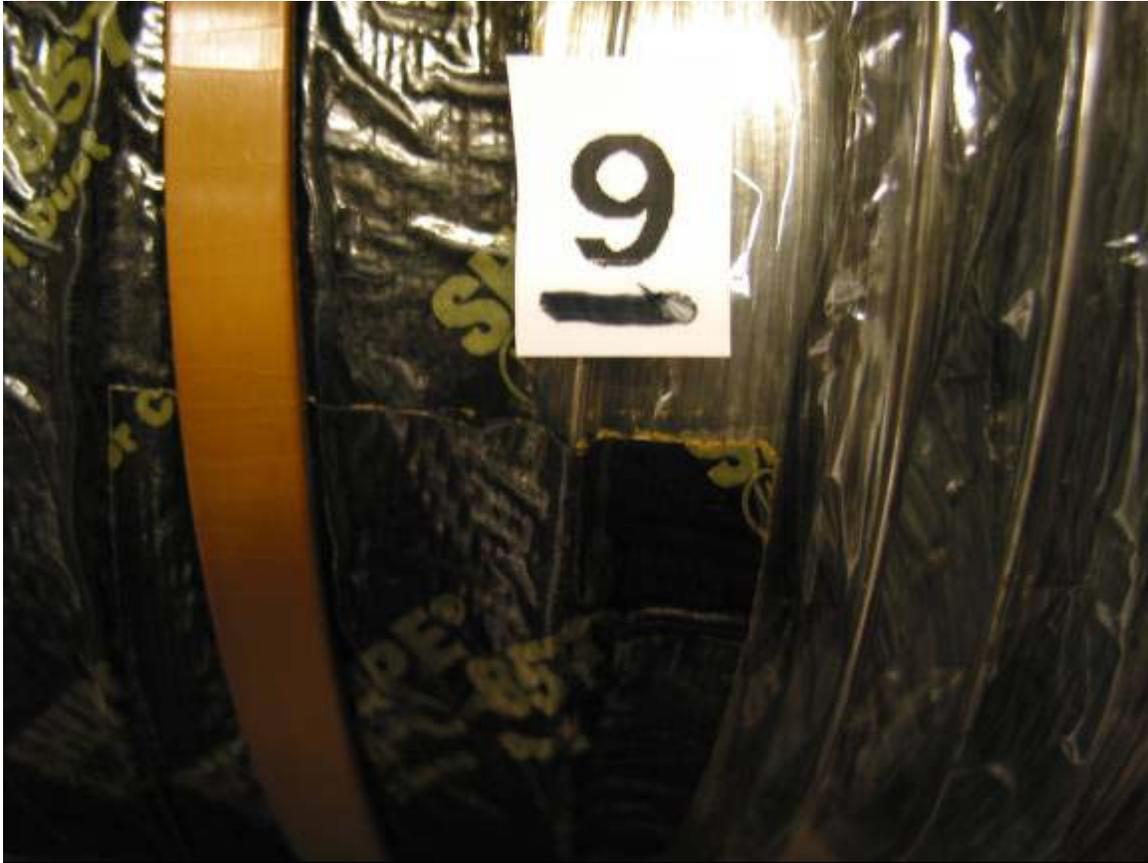
Figure A11. Sample 9. This sample shows almost no shrinkage or delamination.

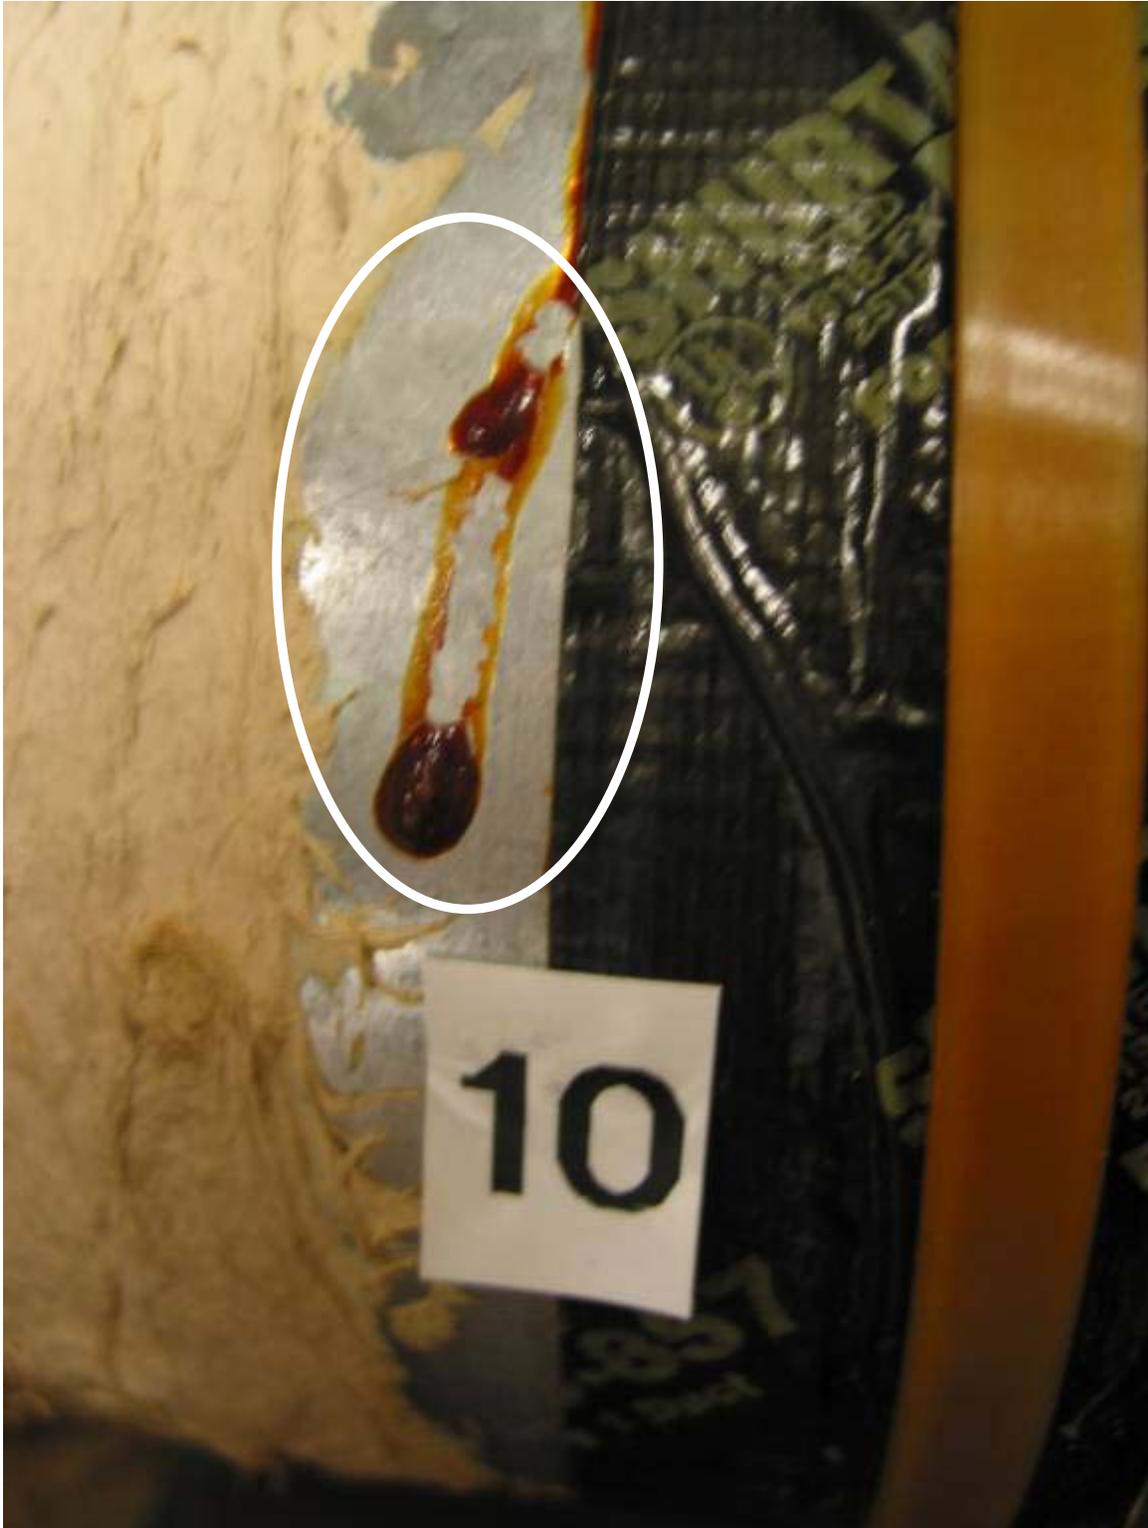
Figure A12. Sample 10. The adhesive has oozed out onto the surface of the duct.

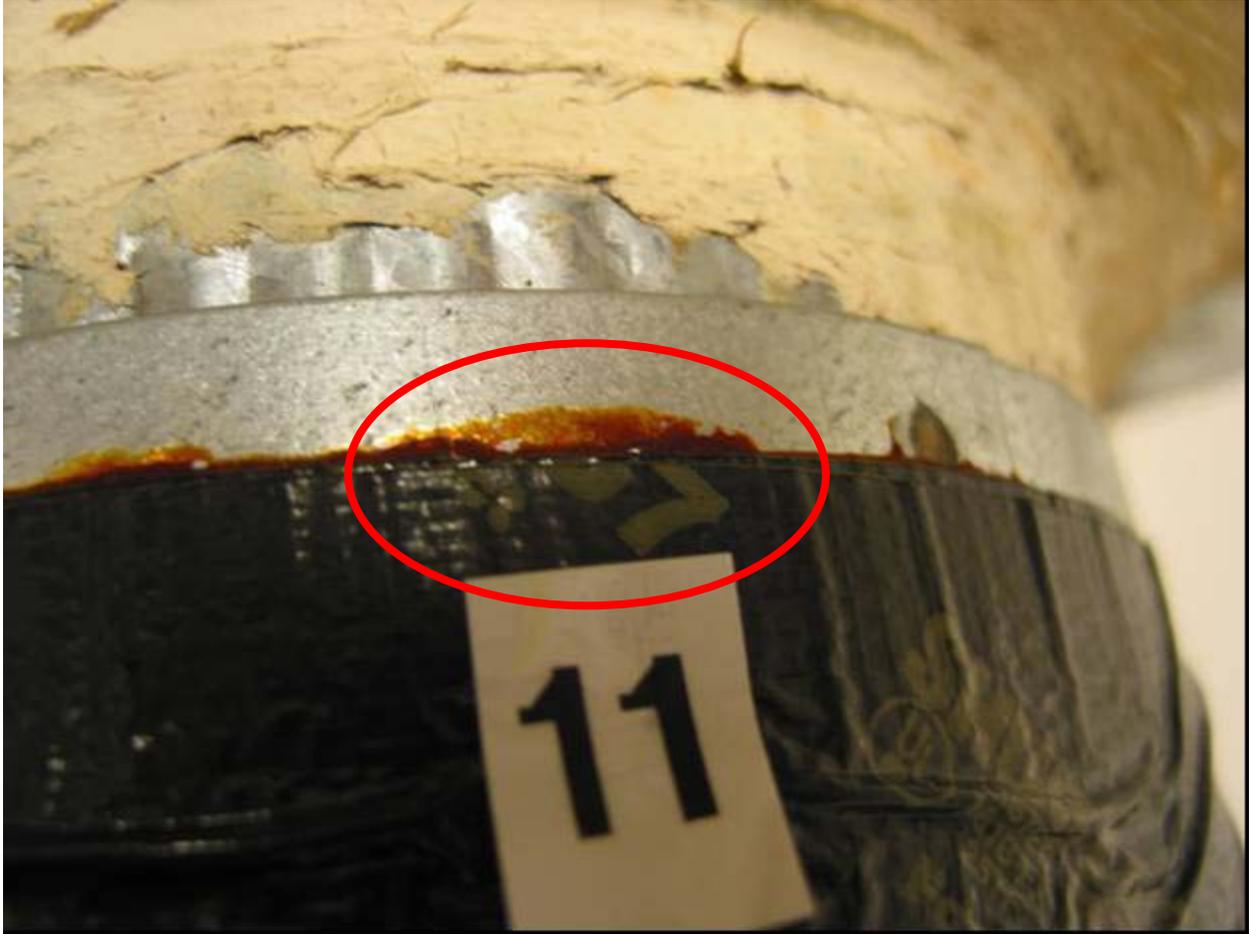
Figure A13. Sample 11. The adhesive has oozed out the edge of the tape.

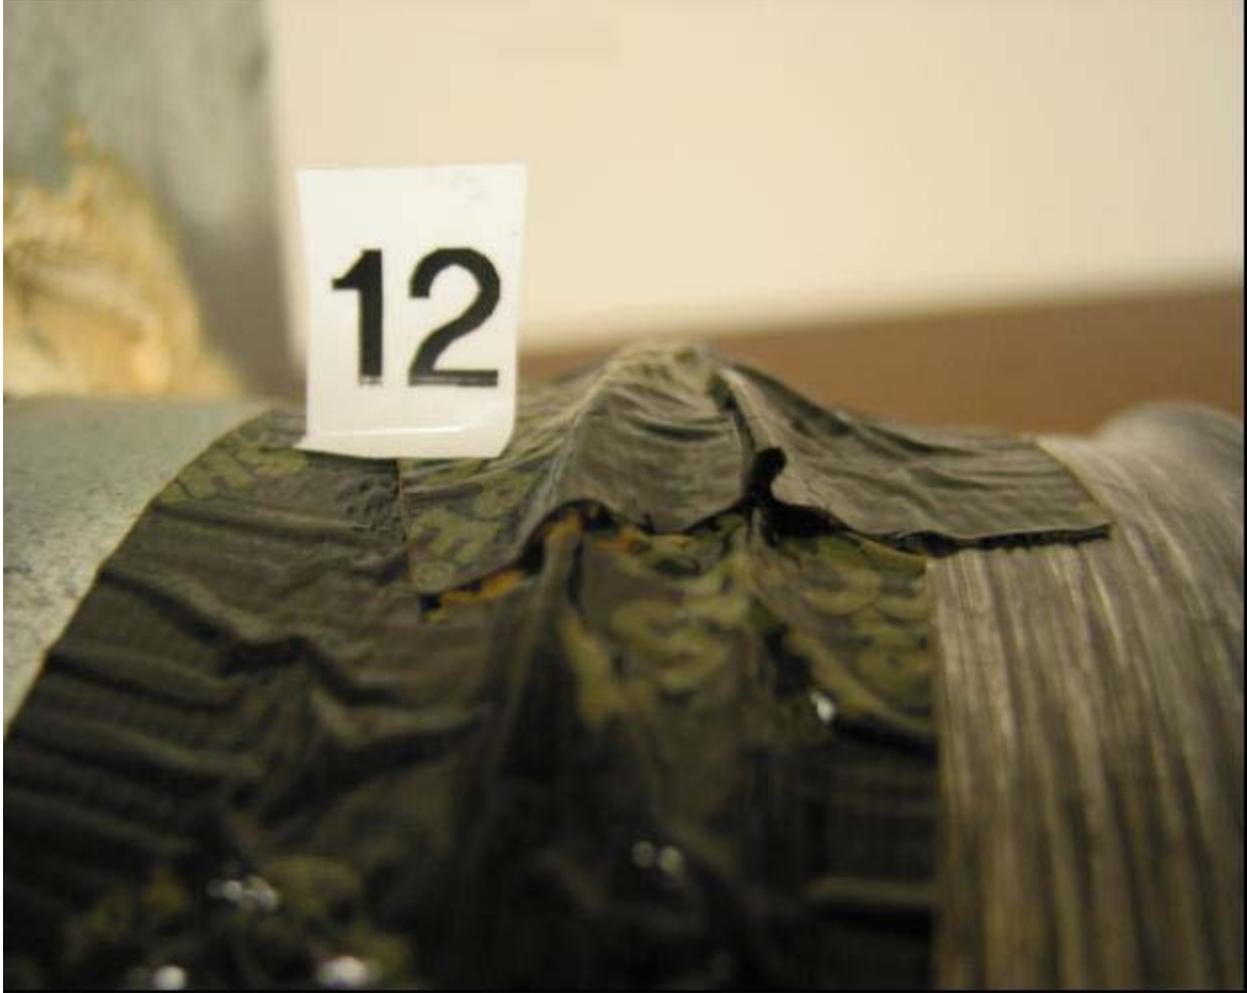
Figure A14. Sample 12. The end of the tape has wrinkled and shrunk.

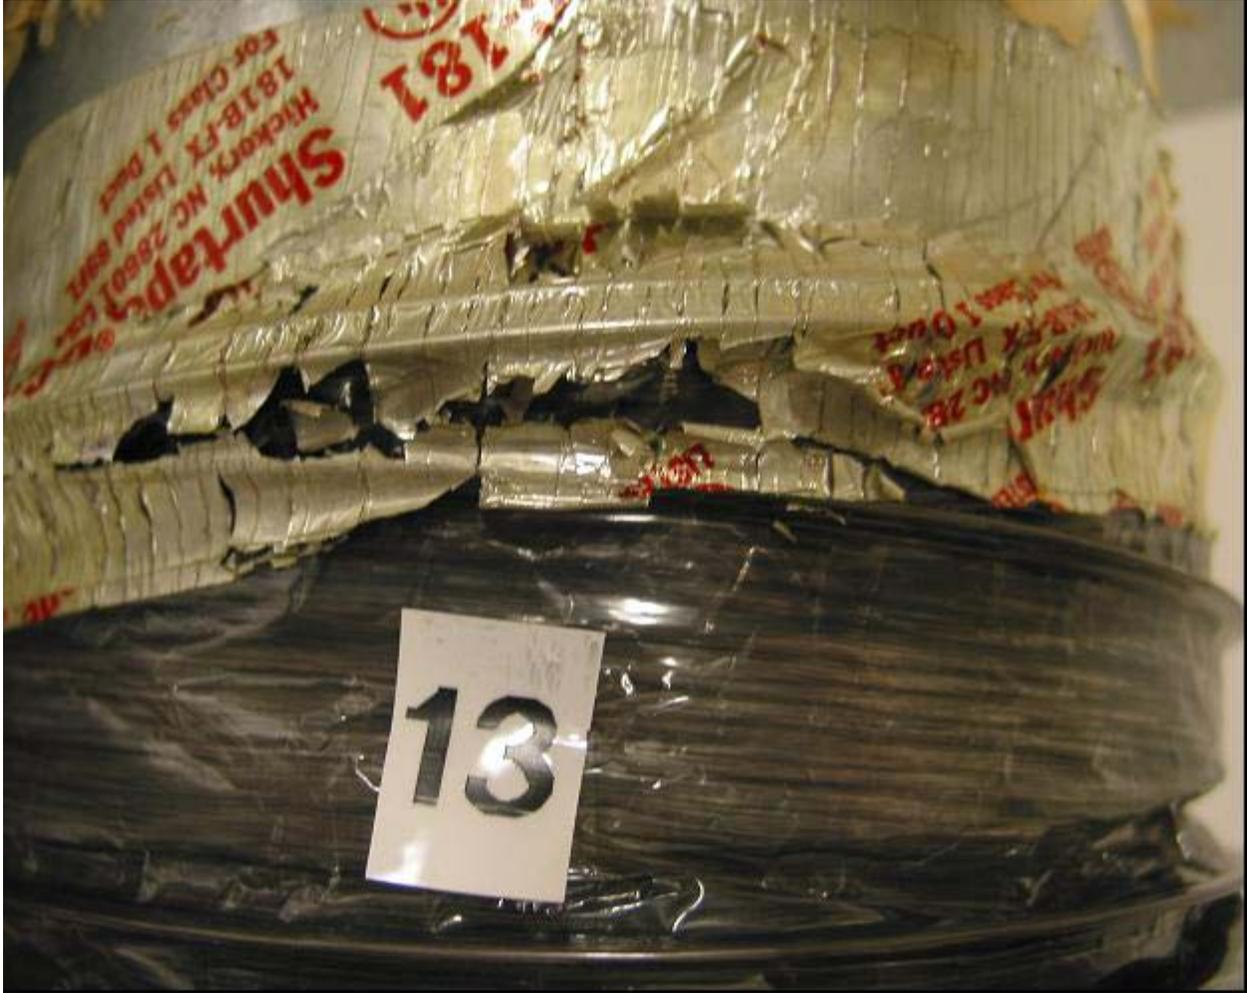
Figure A15. Sample 13. This sample shows cracking and disintegration of the tape
